Environmental Health  
& Engineering, Inc.

February 28, 2013

**RE: PCB Removal and Disposal Work Plan Addendum, Garage Structure,  
100 Arlington Street, Boston, Massachusetts (EH&E 18257)**

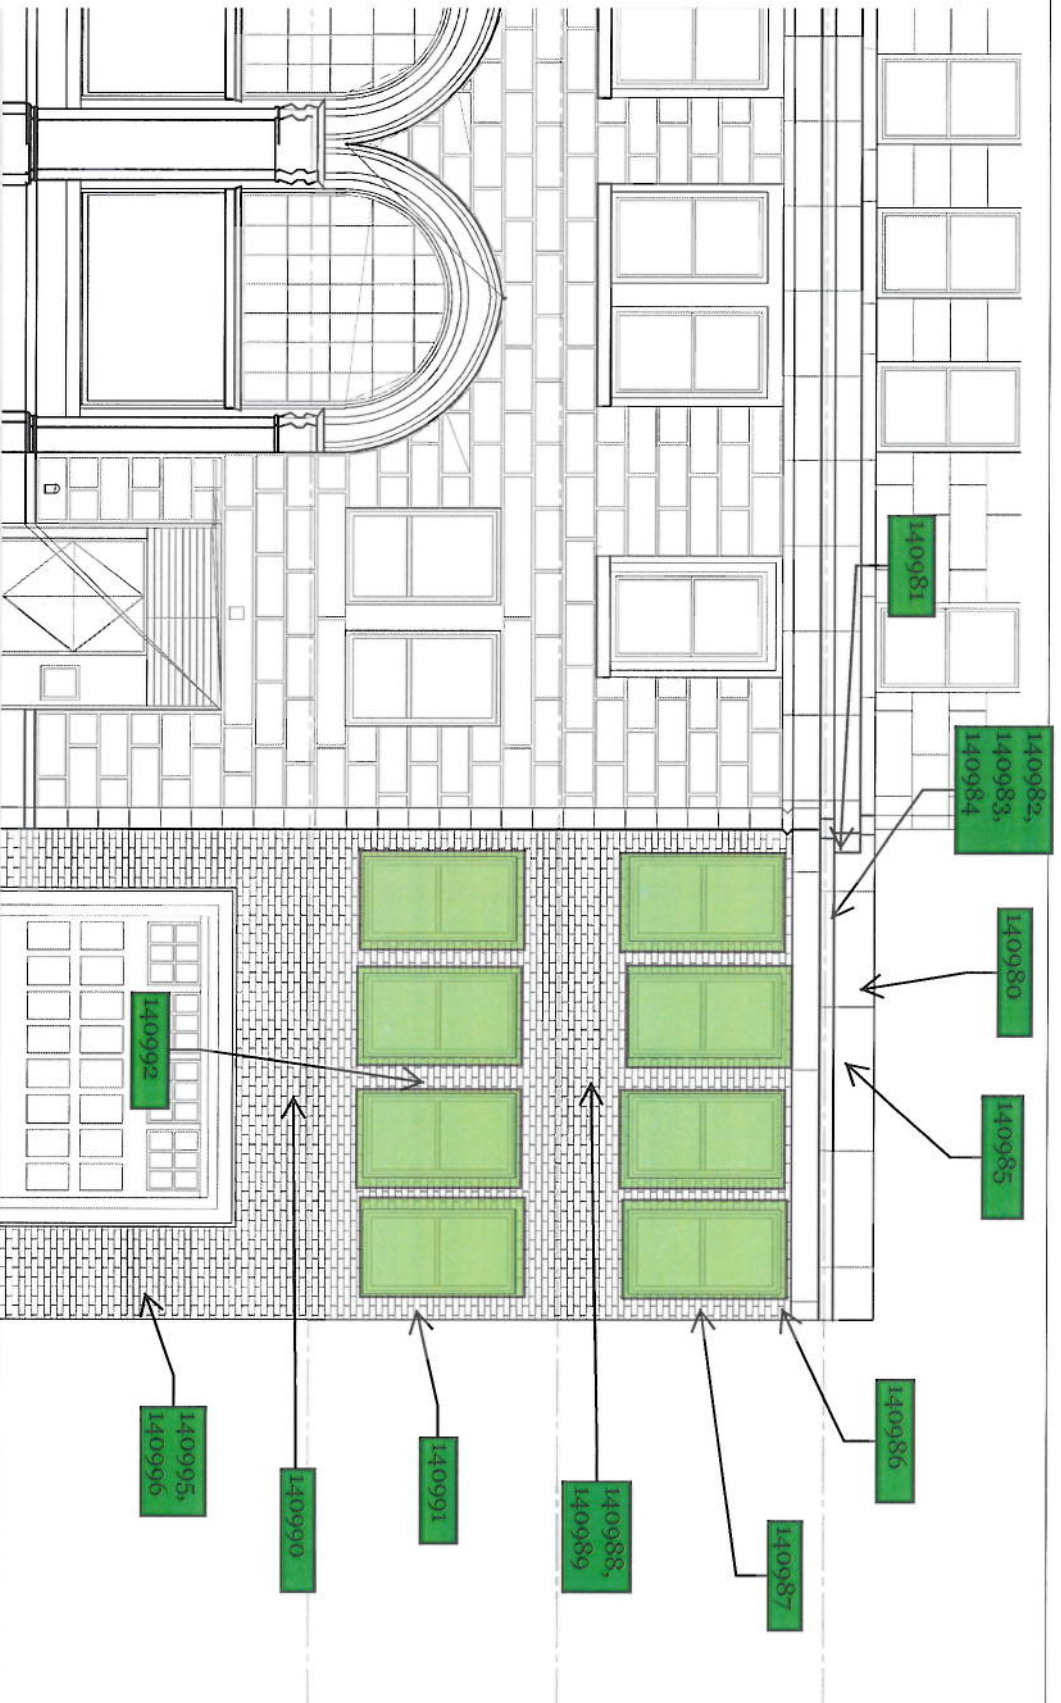
FIGURE: **A.4**

As summarized in Table 1, samples from the second row of brick beyond the PCB-containing caulk at windows at the Piedmont Street elevation all contained concentrations of PCBs below or equal to the 1 ppm criterion for unrestricted reuse. Therefore, at the windows for this

elevation the brick adjacent to the caulk will be disposed with the caulk and windows as mixed PCB/ACM Bulk Product Waste in accordance with the July 16 Work Plan, and disposed at a TSCA/RCRA Title C landfill. In the remaining brick façade portions of the Piedmont Street Elevation, pre-characterization testing indicates that there are no exceedances of the 1 ppm criterion for unrestricted reuse. This brick façade will be removed for structural reasons, but will be disposed as general construction debris.

Window/Caulk/Adjacent Brick  
Removal-ACM and PCB>or = 50  
PPM (TSCA/RCRA Title C Waste)

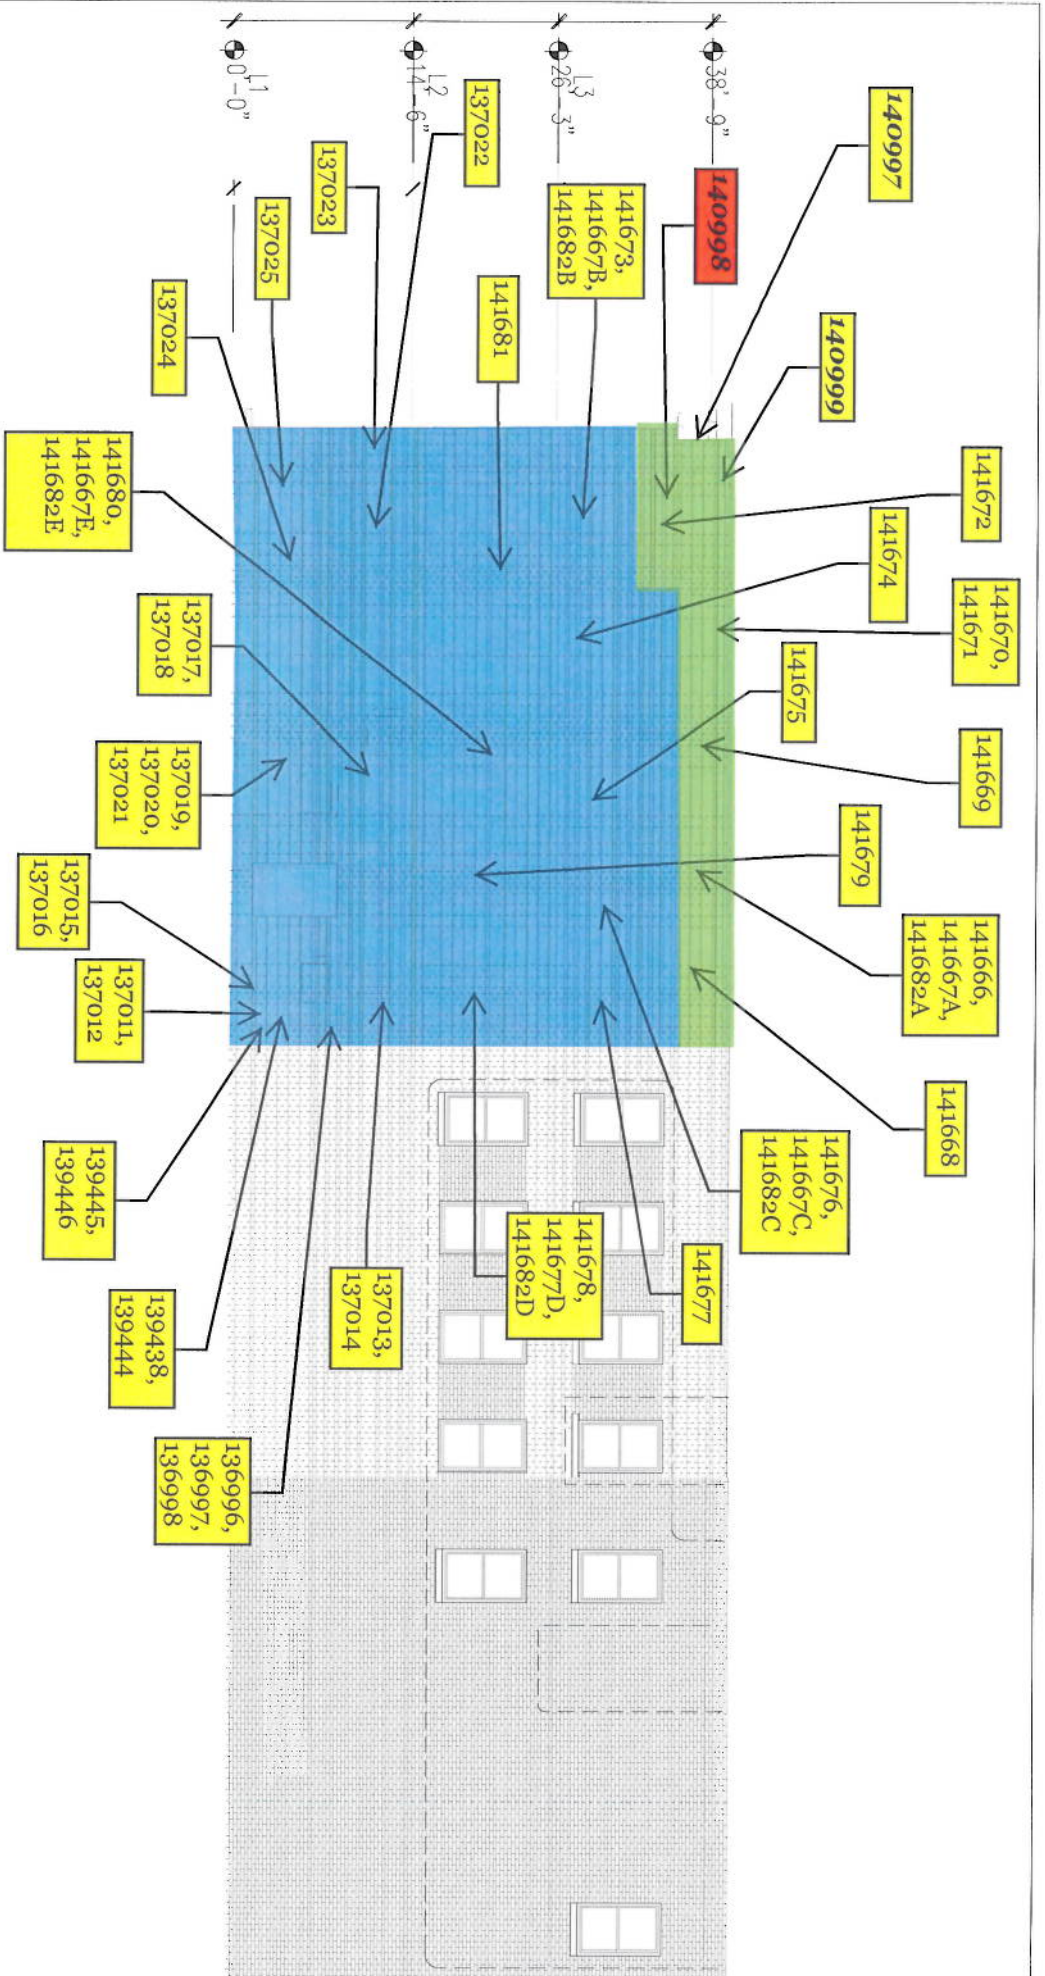
TITLE: Parking Lot Elevation Samples		REVISION: A.3	
CLIENT: The Congress Group		DATE: 02/04/13	
LOCATION: Courtyard & Parking Lot 100 Arlington Street Boston, MA		PROJECT: 18257	
NOTES: 1. LOCATIONS AND DIMENSIONS ARE APPROXIMATE.		PAGE 1 OF 1

In the remaining brick façade portions of the Parking Lot Elevation, pre-characterization testing indicates that there are exceedances of the 1 ppm criterion for unrestricted reuse, but detected concentrations of PCBs are less than 50 ppm (Table 1). These exceedances were demonstrated to often exist beyond the first or second rows of brick and mortar beyond the caulk beads. In these areas, the brick façade will be removed, and disposed at a RCRA Title D landfill licensed to accept construction debris with concentrations of non-liquid PCBs less than 50 ppm.

Caulk/Adjacent Brick Removal-  
ACM and PCB > or = 50 PPM  
(TSCA/RCRA Title C Waste)

Brick Removal PCBs < 50 PPM  
(RCRA Title D Waste)

Bulk sample > or = 50 PPM

Porous material sample < or = 50 PPM

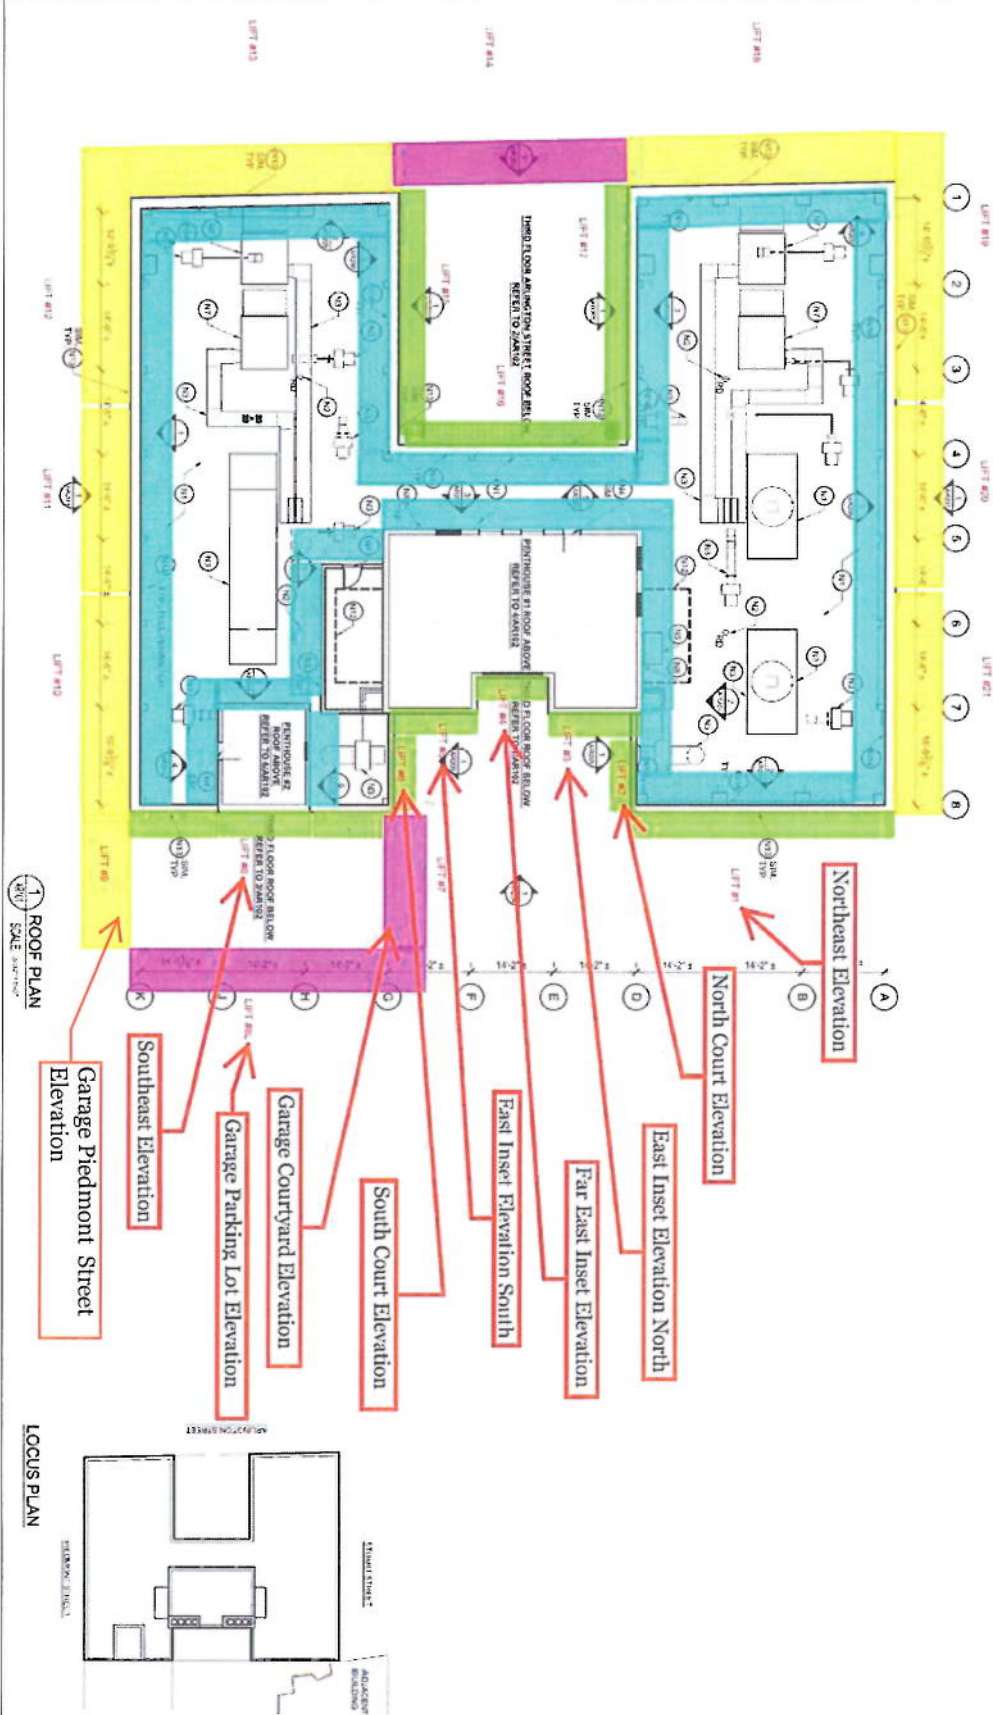
FIGURE ID:  
A.1

- Fraco Tower - Roof Plan 9 EA
- Exterior Scaffolding - Roof Plan 113 LF
- Swing Scaffold - Roof Plan 12 EA
- Roof Parapet Scaffolding Roof Plan 628 LF
